WEAR RESISTANT COATINGS FOR TITANIUM ALLOYS

B. A. Manty, H. R. Liss
Pratt & Whitney Aircraft Group
Government Products Division
West Palm Beach, Florida 33402

15 March 1977

Final Report Period 15 March 1976 through 15 March 1977

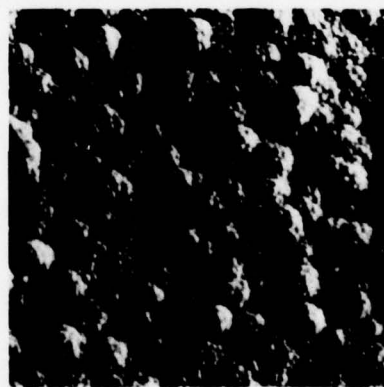
Conventional Chromium
Note Numerous Microcracks

Chromium 1.0% Molybdenum

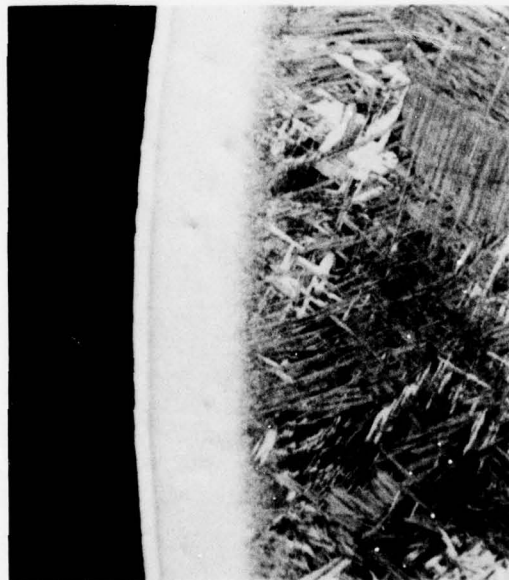
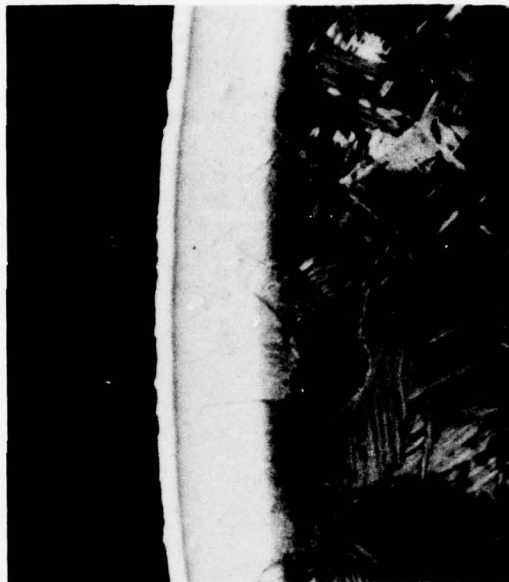
Where a 0V bias was used, the Cr-Mo structure was open, and typical of Zone I structures described by Movchan, et al, (Reference 42). However, the use of a negative bias (ion bombardment) resulted in complete densification. Photomicrographs in Figure 21 show the densification of structure at -25 volt bias for 90% Cr-10% Mo. These results are also typical for 95% Cr-5% Mo, Figure 22. The structures at -15V bias appear identical to the -25V bias structure, Figure 23. No variation in structure with target voltage was noted.

-15V Bias

-25V Bias
